SF Journal of Aviation and Aeronautical Science

Remembering Tenerife: 40 Years Later

Vaz Junior CA*

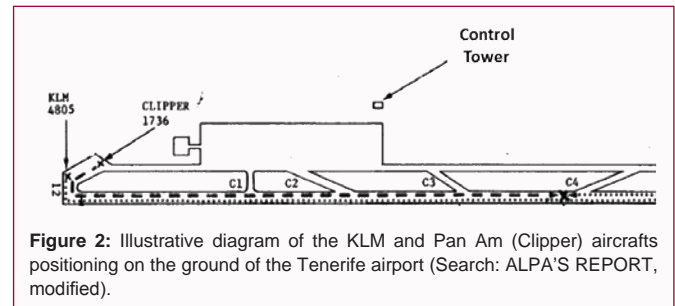
Figure 2: Illustrative diagram of the KLM and Pan Am (Clipper) aircrafts positioning on the ground of the Tenerife airport (Search: ALPA’S REPORT, modified).

Dutch Boeing 747. Nevertheless, the American Boeing should clear the runway at the 3rd exit. ALPA's Report states a few considerations: first, that exit corresponds to Charlie 3 (Figure 2). However, the airport ground maps don't number or identify the taxiways. There was no sign “C-3” on the maps. Not even on the ground it was possible to read such indication “C-3”. Other important point was that the C-3 angle did not favor its use on that position (Figure 2). For an aircraft taxiing from the runway 12 to make use of that taxiway would be necessary to make two curves of 148°: the first curve to the left, and the second curve to the right. An airplane with the dimensions of a Boeing 747 needs large spaces to make curves with such angulation. The ALPA investigators believe that the first curve would be possible, but the second curve (between one taxiway and the other) would not be feasible. As taxiways are usually much narrower than runways, there would not be seen space enough for such maneuvers. In case of such attempt, one of the tires would certainly end up sinking in the grass.

The crew probably believed that the controller was trying to instruct the usage of Charlie 4, the following exit, which had a favorable angulation (Figure 2). The use of C-4 would demand a 35° curve only. From the conversations recordings at the Pan Am cabin, it is possible to infer that the co-pilot reports the moment in which they pass by the taxiways C-1 and C-2, but nothing is said concerning the passing by C-3.
