Infected Exposed Tibial Plate-Can it be a Novel ‘Sinister Popeye Sign’?

Abstract

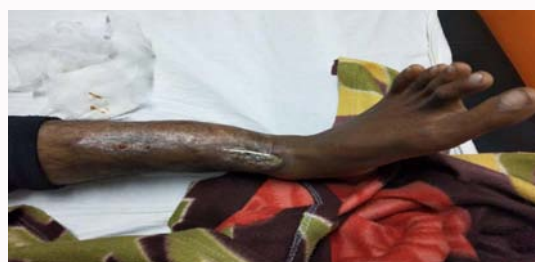
Figure 1: Tibial plate popping out of skin (Sinister Popeye sign).

A male patient of 22 years of age came to us with leg injury following a bike accident around 9 months back. He was diagnosed with Simple transverse fracture of distal 1/3rd of tibia and fibula with no medical co-morbidities. A decision to Open Reduction & Internal Fixation (ORIF) was taken using distal tibial Locking Plate (LCP). After an uneventful hospital course, patient was discharged from the hospital with advice of non weight bearing mobilization and physiotherapy for lower limb joints. However, patient got missed for regular OPD follow up and presented again to us 3 months later with infection (with serous discharge) and tibial plate popping outside the skin (Figure 1). We described it as novel ‘Sinister Popeye sign’, a seemingly nightmarish post surgical complication associated with plating of fractures and with a serious management concerns both for the patient and doctor. Radiograph showed the possibility of non union of both tibia and fibula fracture (Figure 2). A wound swab for culture and sensitivity for possible bacterial organisms was taken, but was found to be negative. He was placed on empirical broad spectrum antibiotics and was planned for staged surgery i.e., to tackle the discharge, exposed implant and soft tissues to start with, for which removal of the tibial plate was done (Figure 3) and was followed up with regular wound care. Simultaneously, hematological parameters were monitored to rule out presence of infection/inflammation like Total Leucocyte Count (TLC), Differential Leucocyte Count (DLC), Erythrocyte Sedimentation Rate (ESR) and C-reactive protein (CRP). It took around 6 months for the wound to completely heal (Figure 4 and Figure 5). Now, second surgery is being planned to address issues of non union and limb shortening by Ilizarov ring fixation, using the principle of

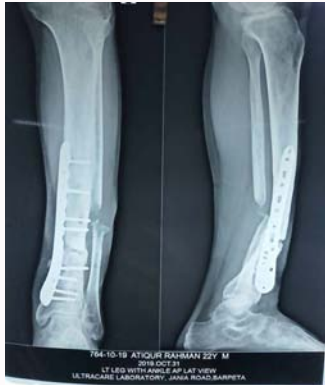
Figure 2: Radiograph showing non union of fracture distal 1/3rd of tibia and fibula with tibial plate *in situ*.

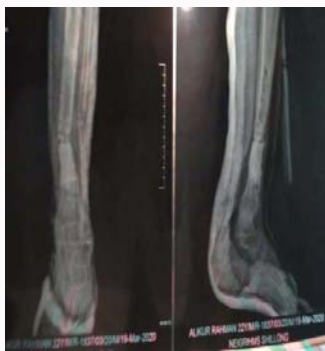
Figure 3: Post operative radiograph showing non union of fracture distal 1/3rd of tibia and fibula with tibial plate removed.
